SHEET 1 OF 3	MONUMENT RECORD CORNER ID: CICr_O25	Quarter Corner Section 34 - T07N-R01W Clear Creek Township Monroe County, Indiana	 OFFICE OF THE MONROE COUNTY SURVEYOR Trohn Enright-Randolph Monroe County Surveyor Rachel Savich Oser Professional Surveyor 119 West 7th Street, Bloomington, IN 47404 (812) 349-2570
-----------------------	---	---	--

MONUMENT RECORD
CORNER ID:
ClCr_O25

Quarter Corner
Section 34 - T07N-R01W
Clear Creek Township
Monroe County, Indiana

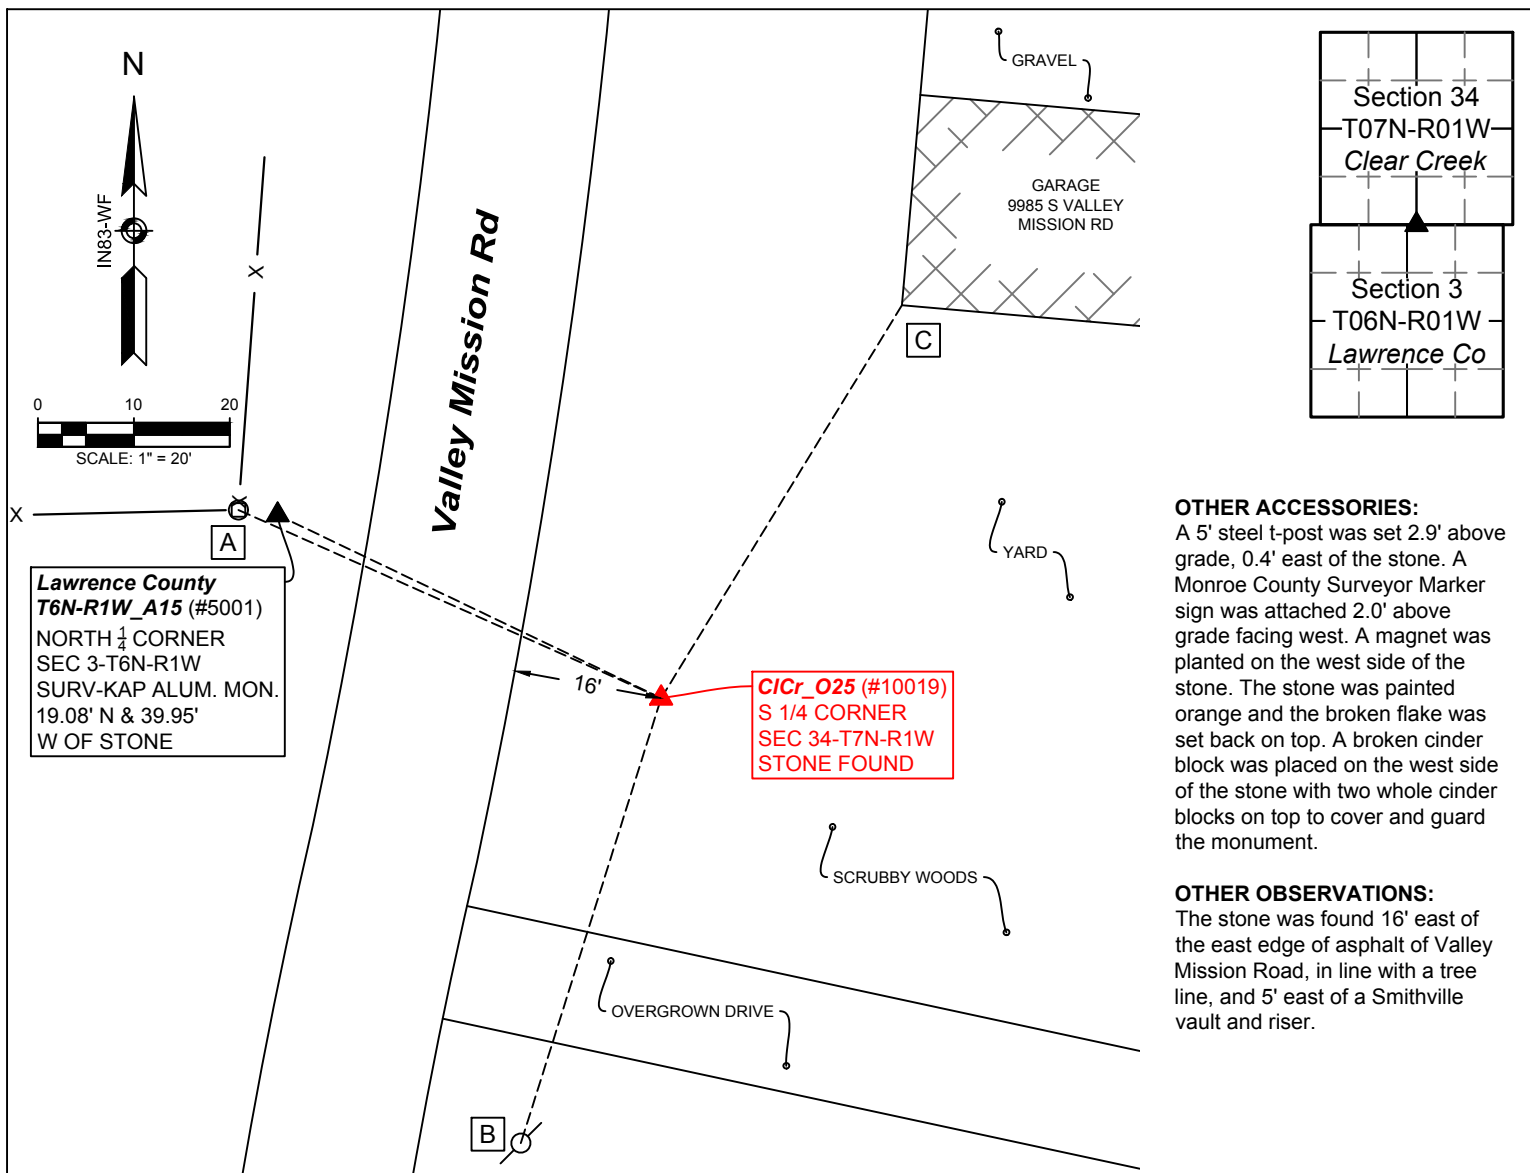
OTHER ACCESSORIES:
A 5' steel t-post was set 2.9' above grade, 0.4' east of the stone. A Monroe County Surveyor Marker sign was attached 2.0' above grade facing west. A magnet was planted on the west side of the stone. The stone was painted orange and the broken flake was set back on top. A broken cinder block was placed on the west side of the stone with two whole cinder blocks on top to cover and guard the monument.

OTHER OBSERVATIONS:
The stone was found 16' east of the east edge of asphalt of Valley Mission Road, in line with a tree line, and 5' east of a Smithville vault and riser.

▲ **Monument Description:** A 0.3' x 0.6' limestone with cut "+" was found 0.4' below grade. The east portion of the cut "+" is not attached to the top of the stone.
State Plane Grid Coordinates: Northing: 1363977.5', Easting: 3116289.1'

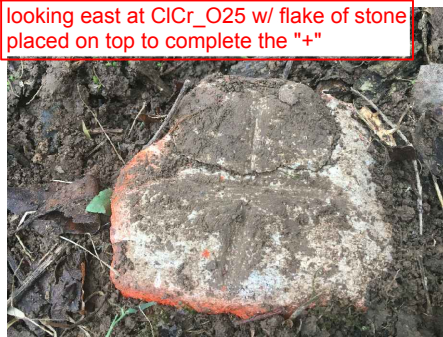
looking east at ClCr_O25
